**AN ASSESSMENT OF
ABANDONED MINES IN
NORTHERN SASKATCHEWAN
(YEAR 3)**

MAY, 2003

**PREPARED FOR:
SASKATCHEWAN ENVIRONMENT**

Prepared by: Clifton Associates Ltd.
on behalf of
P.A.N.S. Joint Venture

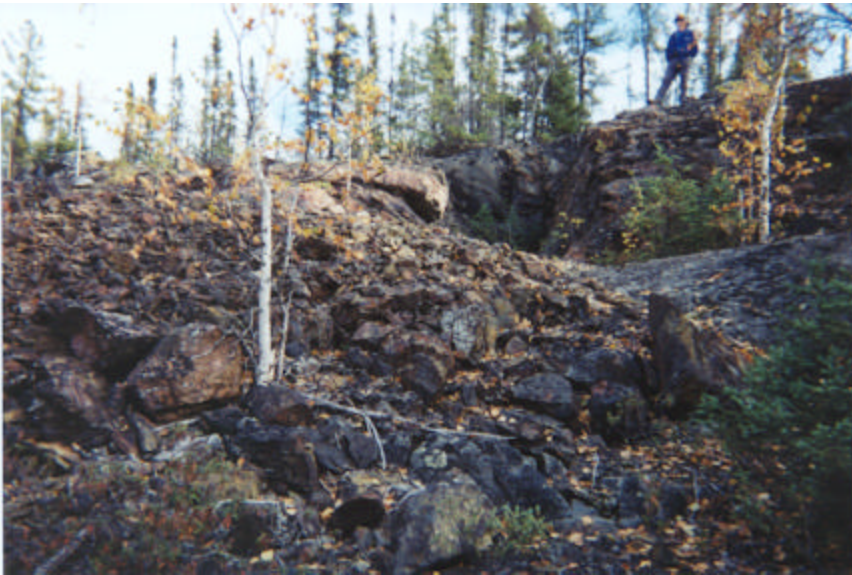
Northeast of the shaft is a deep trench cut into a hillside. The trench faces a step 3 – 5 m drop exists from the hill-side to the bottom of the trench (Figure 6.1-2). The trench is about 10.15 m long and 3 m wide.

Photograph 6.1-2. Neely Lake-Trench
and Waste Rock-September 30, 2002.

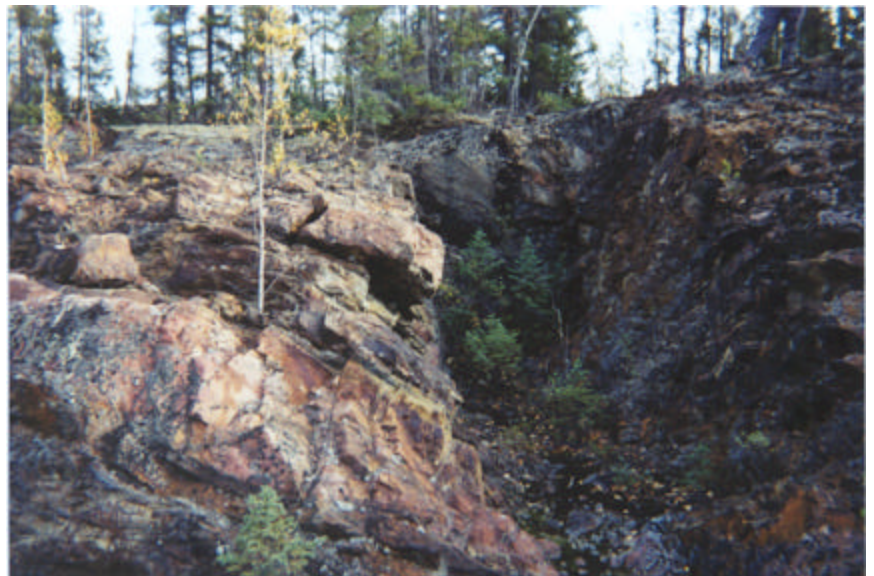
Photograph 6.1-3. Neely
Lake-Trench-September 30, 2002.

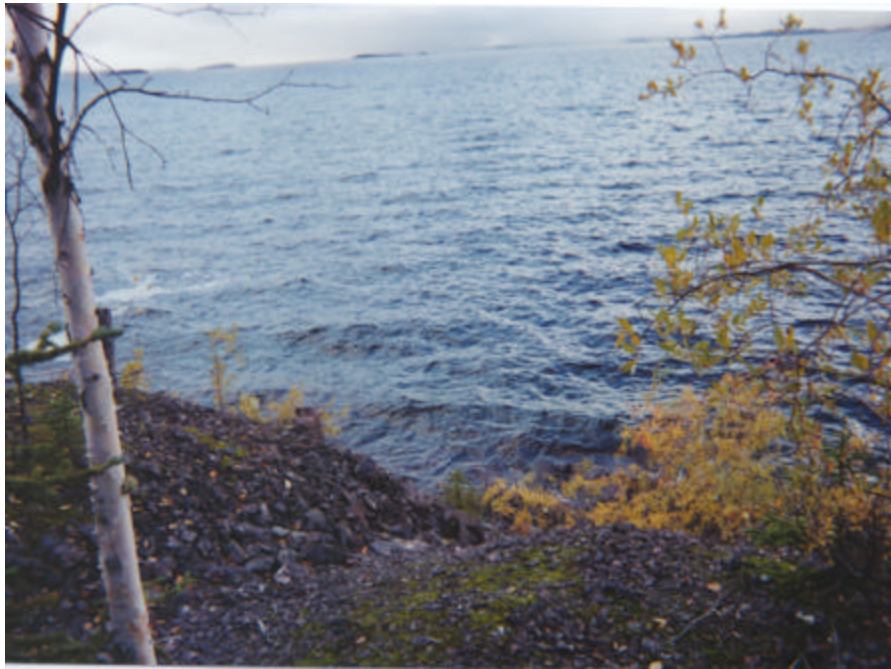
The adit was open with about 20 m³ of waste rock spread out toward Tazin Lake. There was no waste rock in the Lake. The waste rock did not have any visible sulphides or evidence of acid generation.

Photograph 6.2-2. New Mylamaque Site-Waste Rock Extending to
Shore of Tazin Lake-September 30. 2002

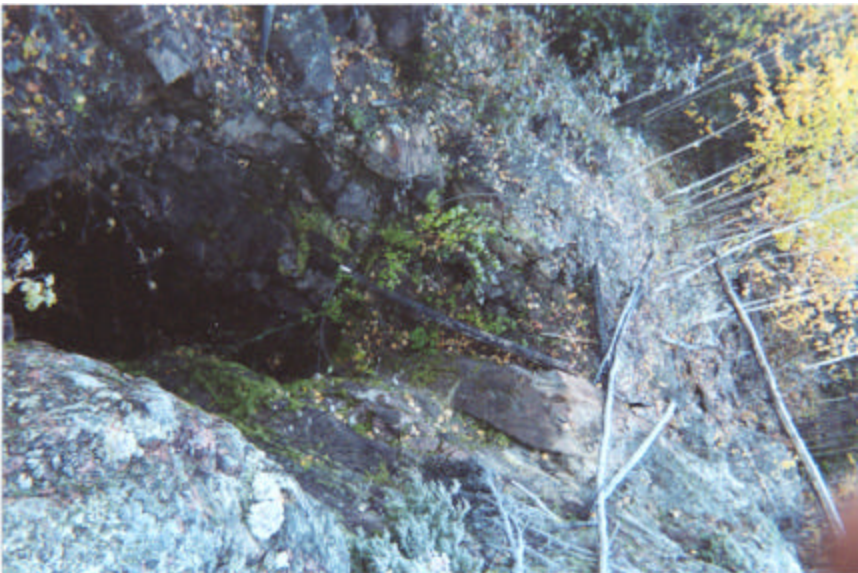
Photograph 6.3-2. Rix Athabasca
Site-Open Trench-October 01, 2002

Follow-up work should focus on pushing waste rock and debris back into the trench to remove the public safety hazard and to reduce the gamma exposure present by the waste rock.

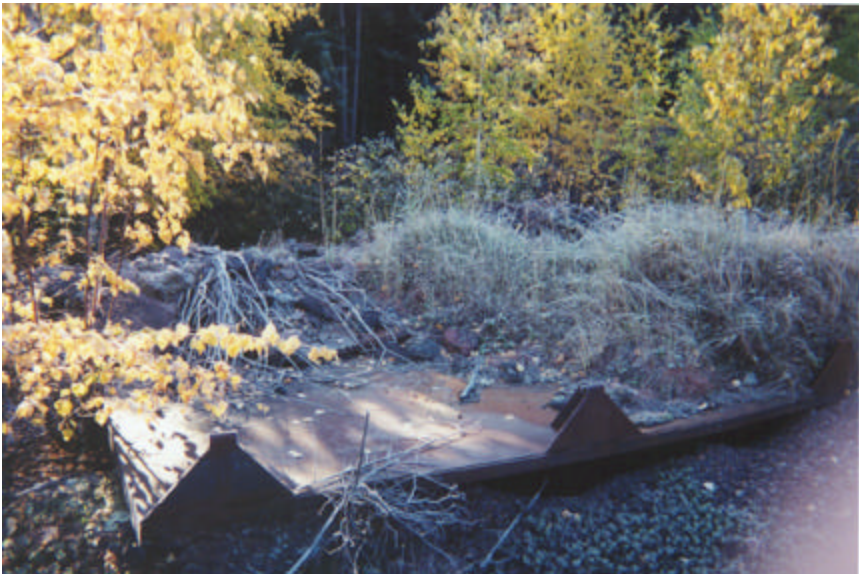
Photograph 6.3-3. Rix Athabasca
Site-Debris-October 01, 2002.

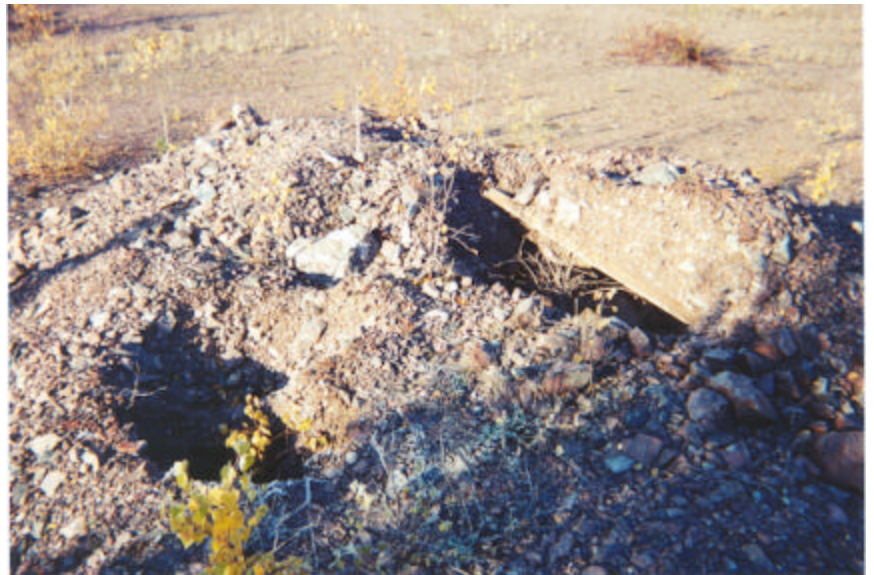
Photograph 6.4-1. Cenex Site-Slumping
Waste Rock at Shaft-October 01, 2002

Given the easy access to the site, work should focus on securing the shaft openings. This could be done by excavating existing material away and attracting secure concrete shaft covers on all these shaft openings

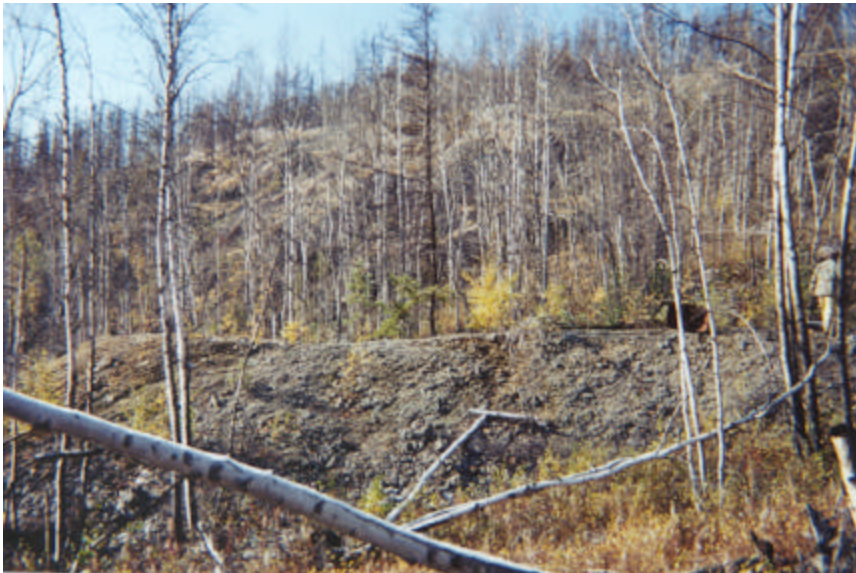
Photograph 6.4-2. Cenex Site-Debris and
Waste Rock-October 01, 2002

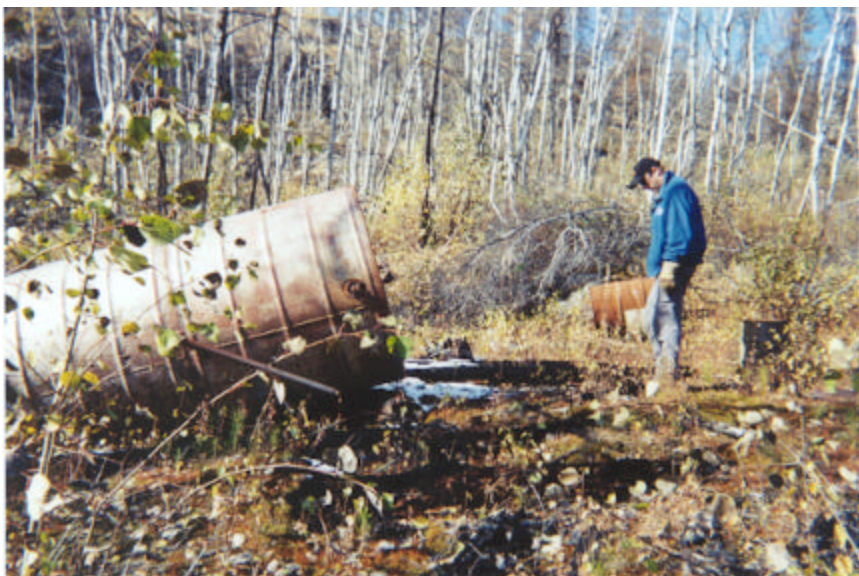
Photograph 6.5-3. Don Henry Site-Debris-October 01, 2002.

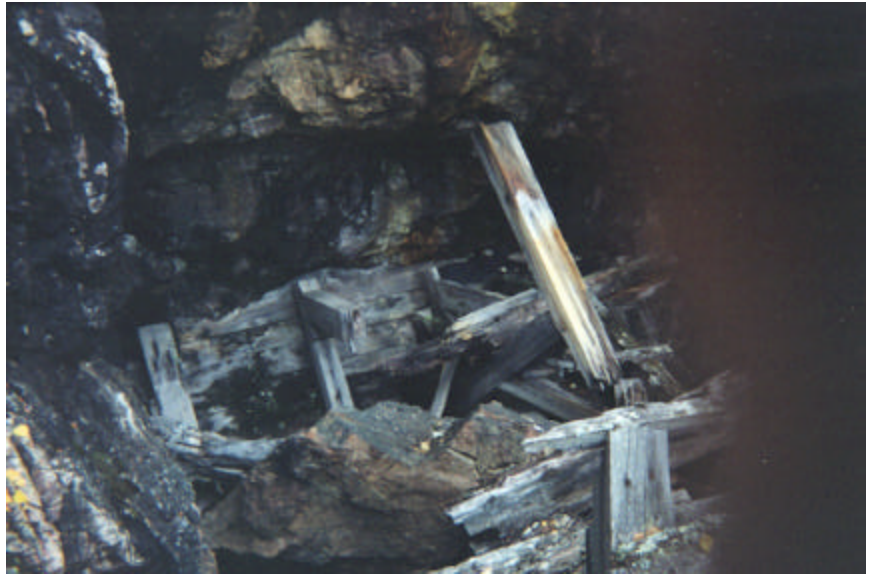
The adit appears to be steeply declining although the opening is plugged with lumber. There is a high vertical drop above the adit from the adjacent hillside.

Photograph 6.6-1. Box Mine Site-Portal-October 01, 2002.

Follow-up work on the adit should be combined with clean-up work at other parts of the property and should include pushing debris into the adit and blasting it closed to permanently seal the opening and to remove the steep rock frame above the adit.

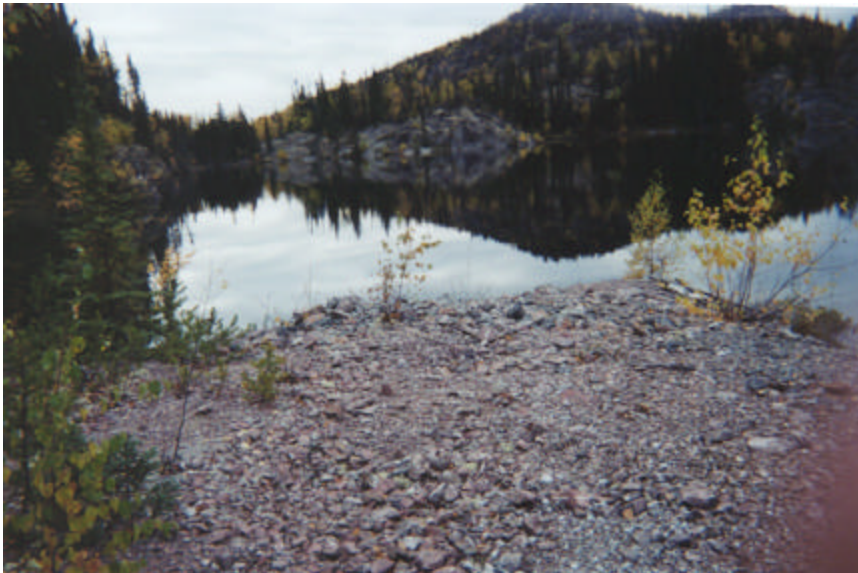
Photograph 6.6-2. Box Mine Site-Waste Rock Extending into Frontier Lake-October 01, 2002.

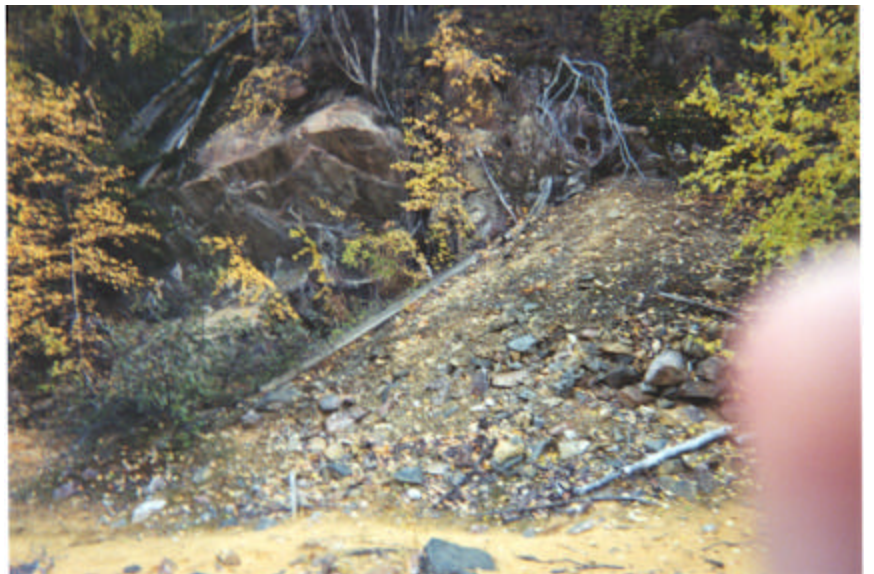
A second adit is located about 300 m north and 300 m east of the adit on Vic Lake. The second adit is located on the north end of Vic Lake where tailings exist. The adit has been sealed with waste rock and does not present any type of hazard.

Photograph 6.6-3. Box Mine Site-Sealed Portal-October 01, 2002.

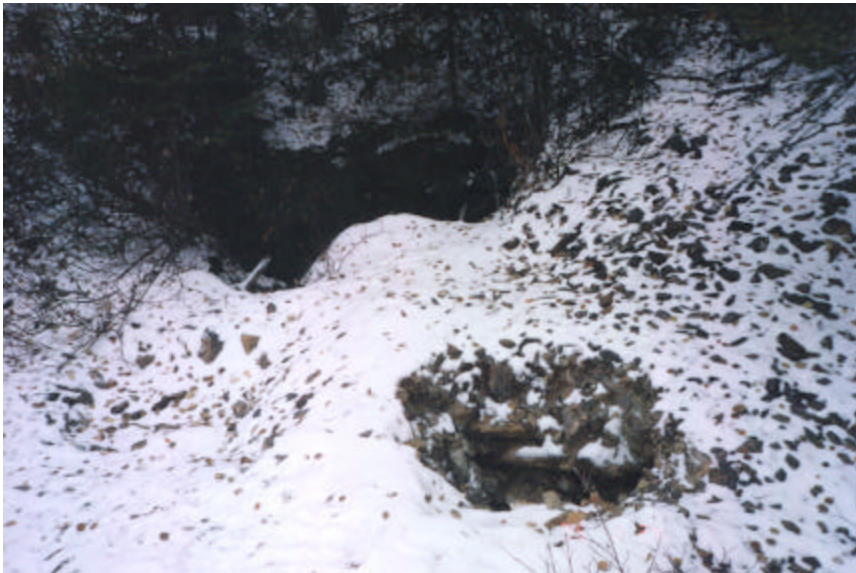
Photograph 6.7-2. Prince Albert Mine-Stope Opening-October 18, 2002

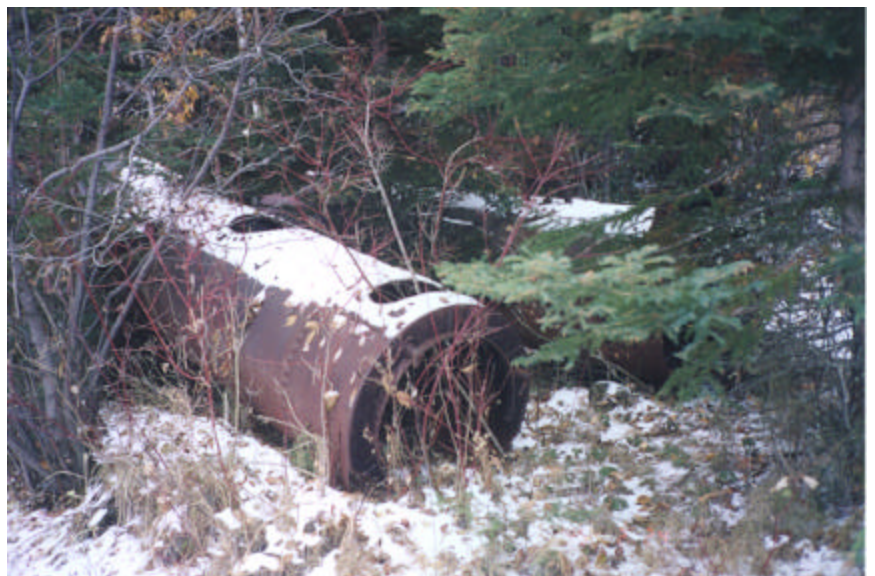
Photograph 6.7-3. Prince Albert Mine-Discarded Equipment-October 18, 2002.

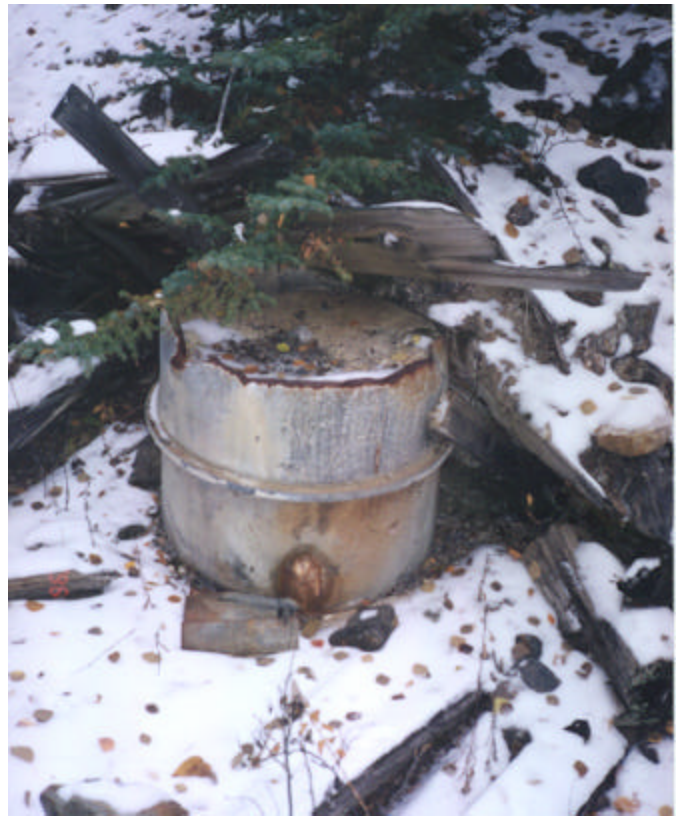
Photograph 6.7-5. Prince Albert Mine-Discarded Barrel with Sand or Concentrate-October 18, 2002

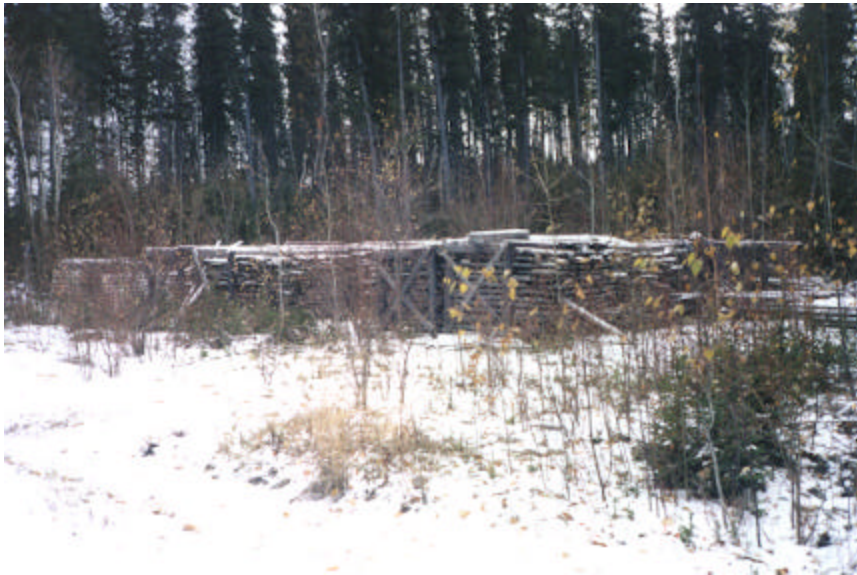
There are no buildings or ruins in the immediate area of the decline. However, Claude Resources maintains an exploration camp 250m west of the decline. The camp consists of a double trailer office/bunkhouse, a wash trailer, and a core shack. Standard stove oil storage tanks (909 litre capacity) were situated outside the trailers. Drill core stacks were also at the camp. The camp was in a clean and tidy condition.

Photograph 6.8-6. Laurel Lake Gold Mine-Exploration Camp-October 18, 2002.

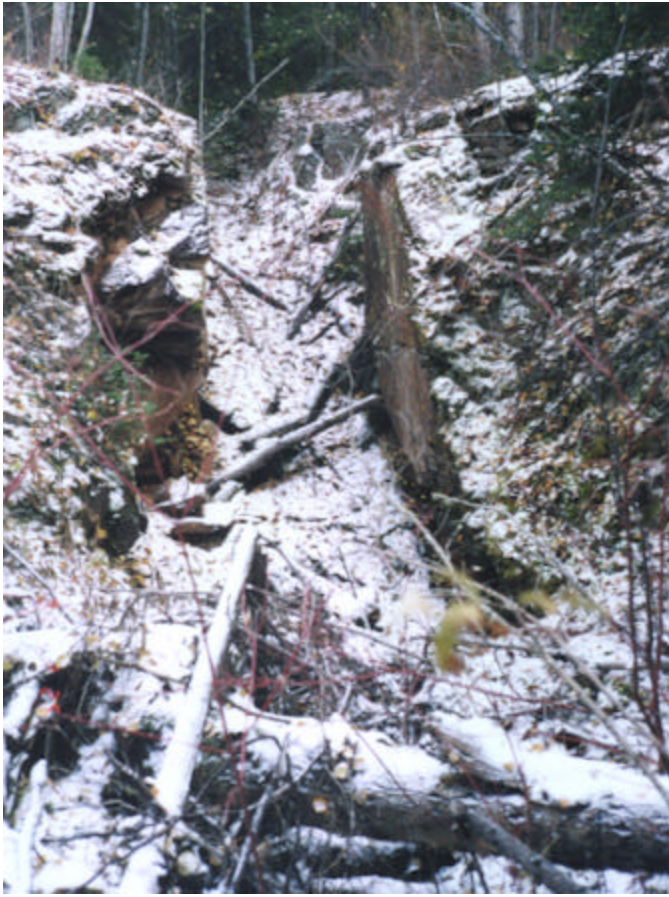
Trenches 'A' to 'H' range in length from 6 m to 18 m, 1.5 m to 3.6 m wide, and are nominally 1.8 m deep. However, Trenches 'F' and 'G' were 3 m and 6 m deep in places. Figure 6.9-2 provides the measured dimensions of each trench. The trenches have steep side slopes to vertical rock walls and are stable. Scrub bush and several mature spruce and birch trees (8 cm to 16 cm diameter) have grown in the trenches. Since the trenches have been excavated into the hill slope, and thus themselves sloped downward to the west, there was no accumulated water in these workings.

Photograph 6.9-4. Amisk Gold Mine-Trench 'F'-October 19, 2002.

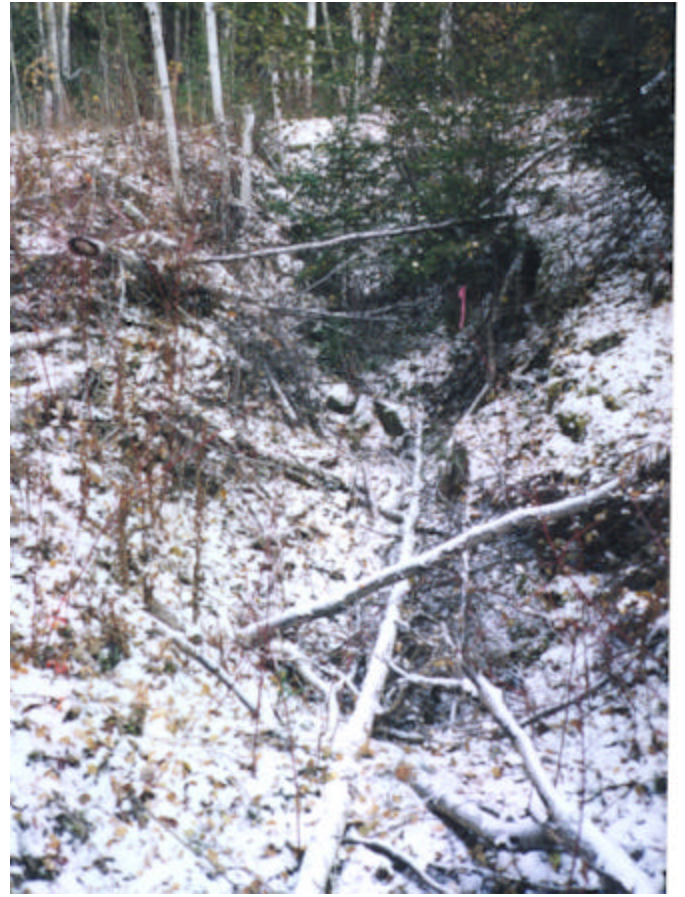
Photograph 6.9-5. Amisk Gold Mine-Trench 'G'-October 19, 2002.

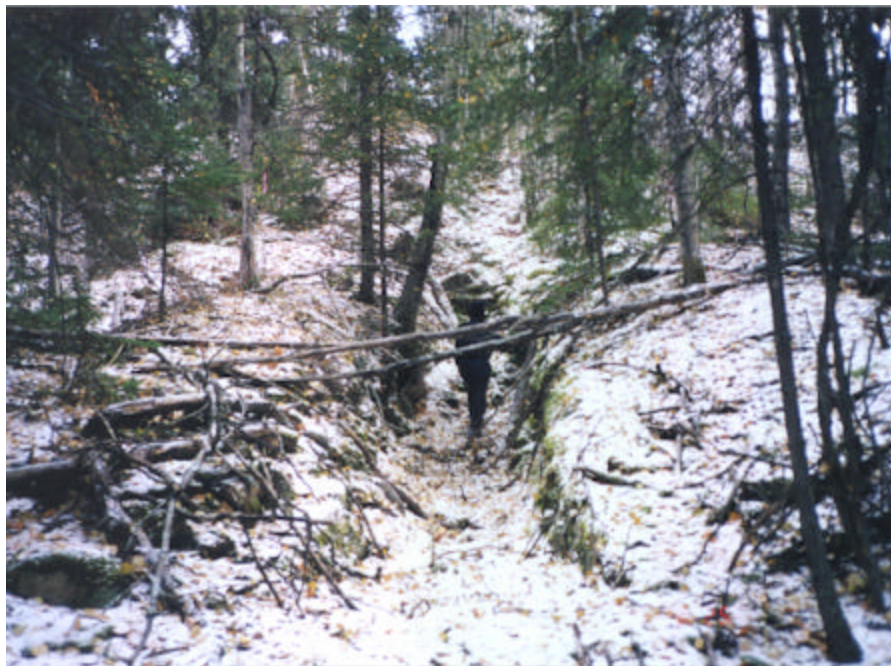
Photograph 6.9-4. Amisk Gold Mine-Trench 'H'-October 19, 2002.

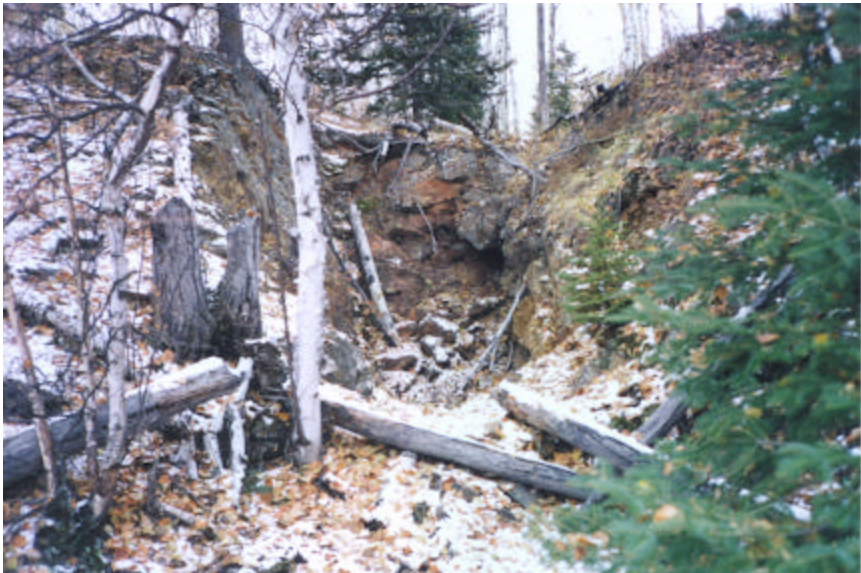
Mine workings consist of three short and moderately deep trenches, a shallow shaft and two small pits exposed over a distance of 30 m along the east slope of the ridge. The workings expose a sulphide stained shear containing 5% massive and disseminated sulfides in a metavolcanic rock. Figure 6.10-2 provides the measured dimensions of each working. For purposes of this investigation, the various workings were assigned letter identifiers, A to E, in order to distinguish them from each other.

Photograph 6.10-2. Beaver Mine-Trench
'A'-October 19, 2002.

Follow-up should focus on sealing the shallow shaft since it poses a public safety risk. The shaft opening could be closed by backfilling with local rock. The walls of the deeper trenches could be back-filled or blasted to reduce the vertical wall heights, thus lessening risk of a fall hazard. Scaling of loose rock can also be considered if the trenches are not backfilled.

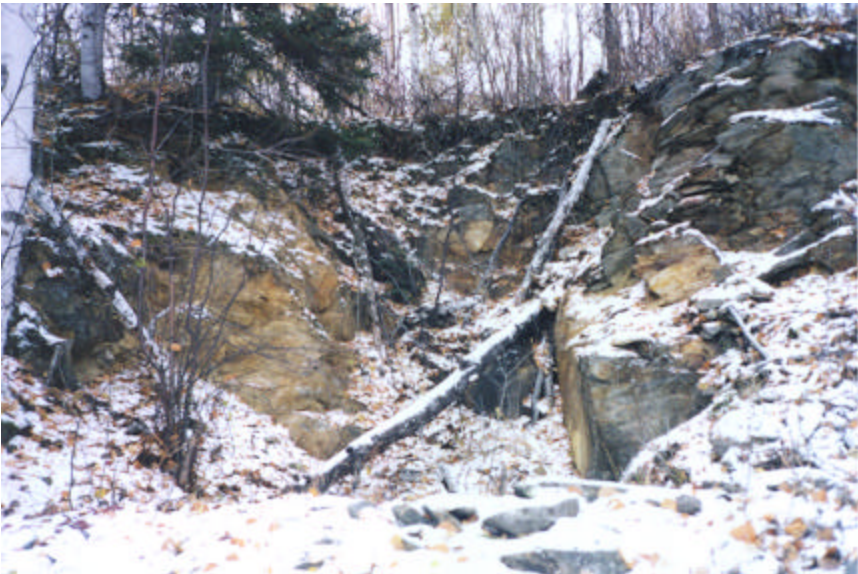
Photograph 6.10-3. Beaver Mine-Trench
'B'-October 19, 2002.

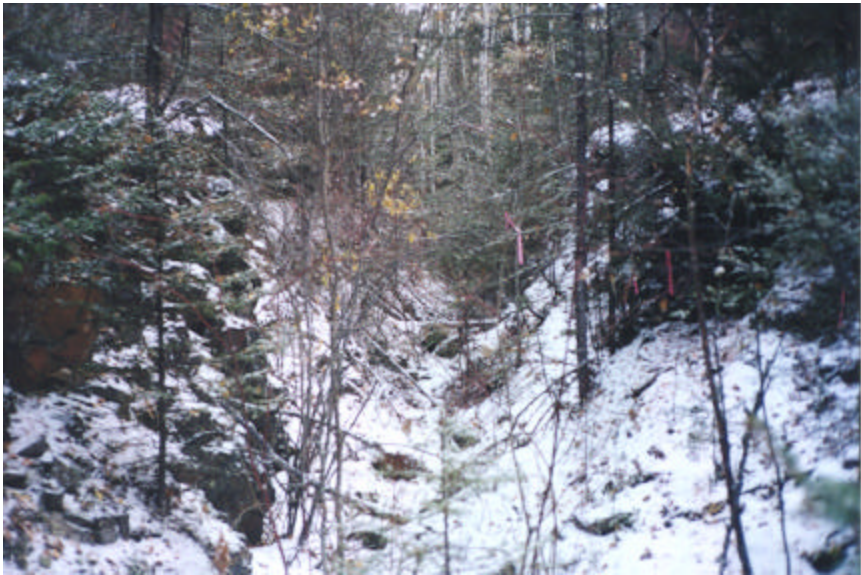
Photograph 6.11-2. Waverly Island Site-Trench 'B'-October 20, 2002.

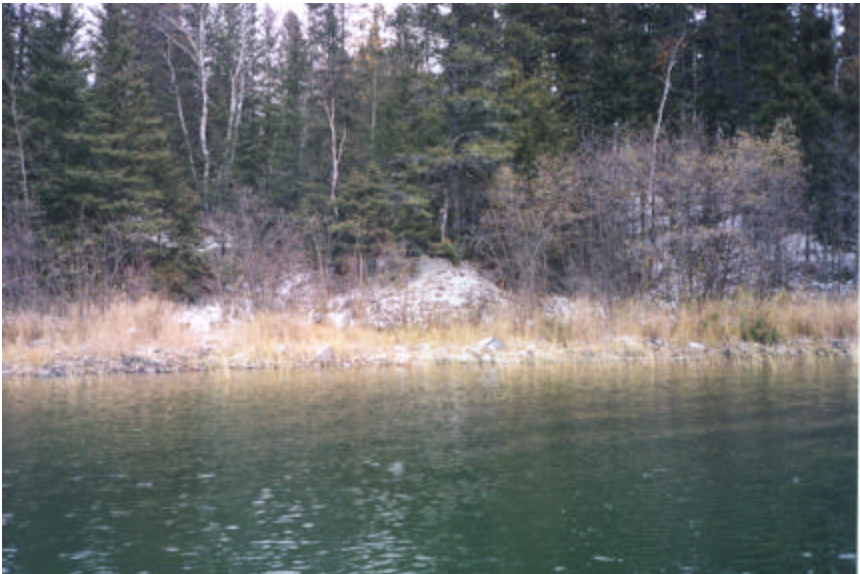
Photograph 6.11-3. Waverly Island Site-Shoreline at Pit 'B'-October 20, 2002.

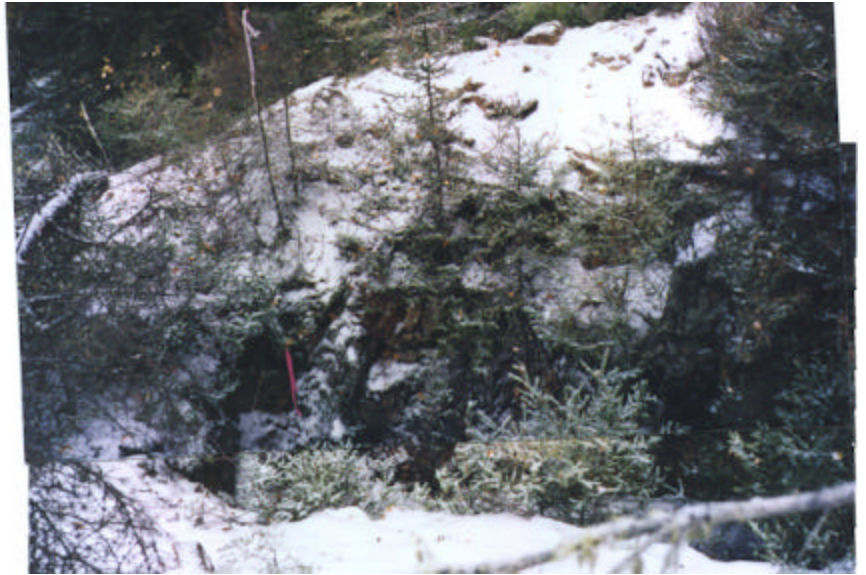
Photograph 6.11-4. Waverly Island
Site-Pit 'A'-October 20, 2002.

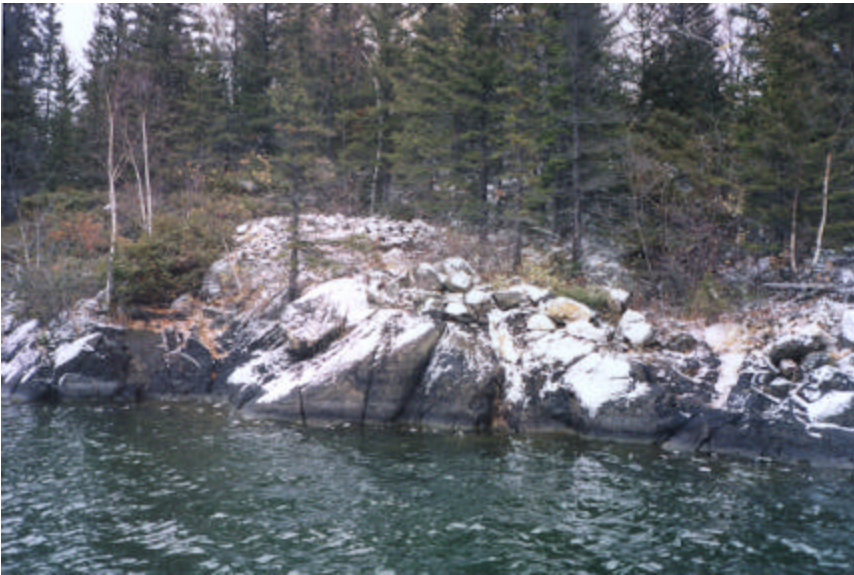
Photograph 6.11-5. Waverly Island
Site-Pit 'B'-October 20, 2002.

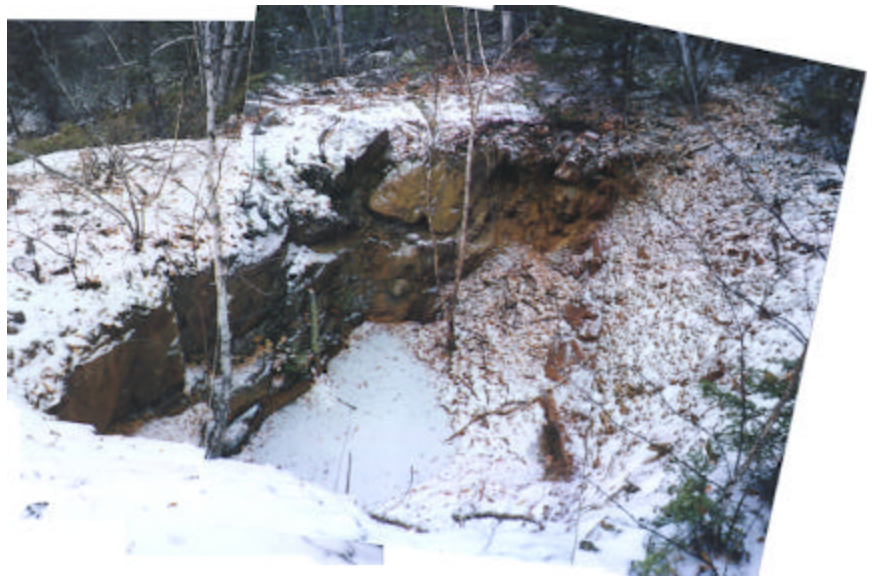
Photograph 6.11-6. Waverly Island
Site-Pit 'C'-October 20, 2002.

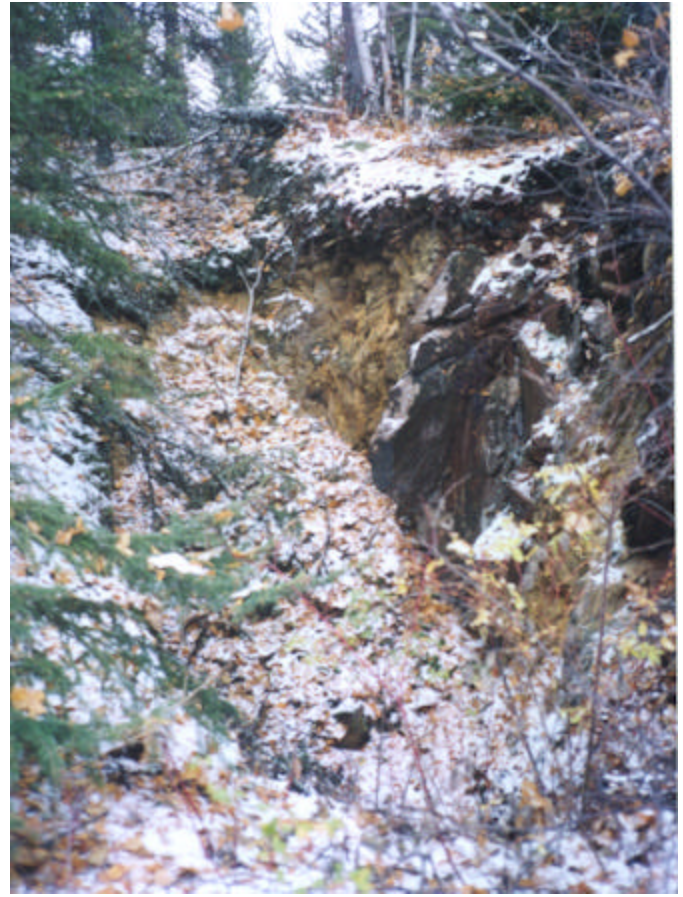
Trenches 'A', 'B', 'C' and 'D' range in length from 2 m to 4.6 m, and nominally are 1.4 m wide and 0.8 m deep. Figure 6.12-2 provides the measured dimensions of each trench. The trenches expose sulphide stained shear zones. All trenches are slightly sloped down toward the lake and were dry. Massive arsenopyrite lenses are exposed in Trench 'B' and Trench 'C'. Slumping of soil and friable rock has occurred along the length of the trenches. Scrub bush, and immature to mature (12-cm diameter) trees have regrown along the trench edges and several trees have encroached inside some trenches. These shallow trenches are not a significant public safety hazard.

Photograph 6.12-1. Sonora Deposit-Trench 'C'-October 20, 2002.

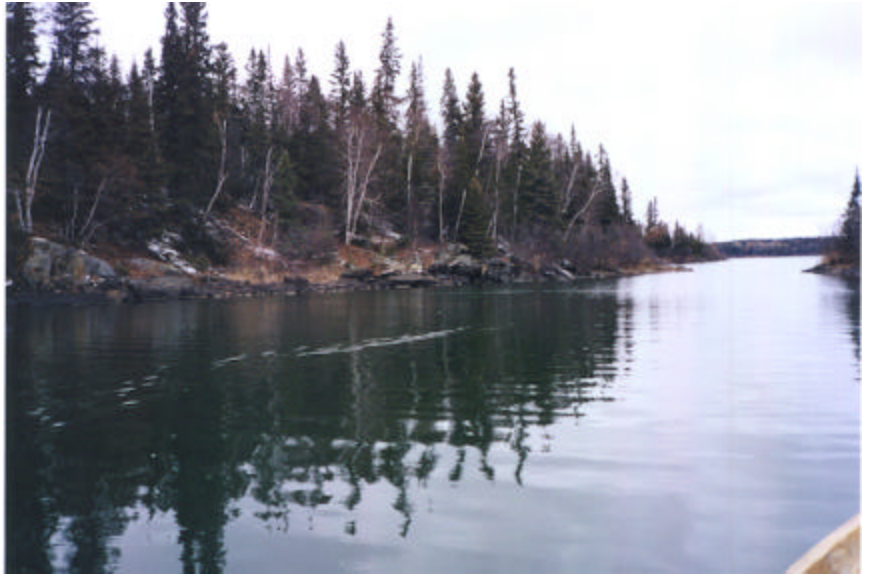
Photograph 6.12-4. Sonora Deposit-Area of Shoreline Trenches-October 20, 2002.

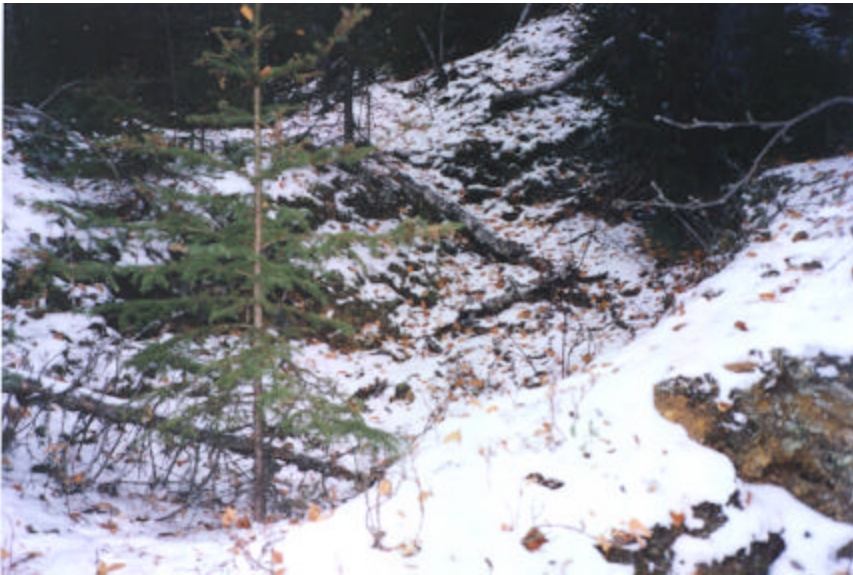
Photograph 6.12-5. Sonora Deposit-Trench 'A'-October 20, 2002.

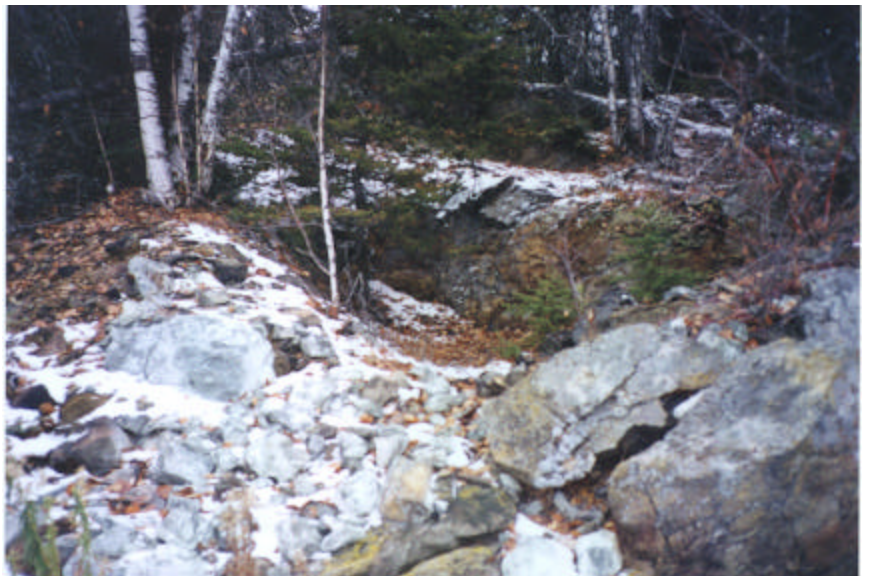
Photograph 6.12-6. Sonora Deposit-Trench 'B'-October 20, 2002.

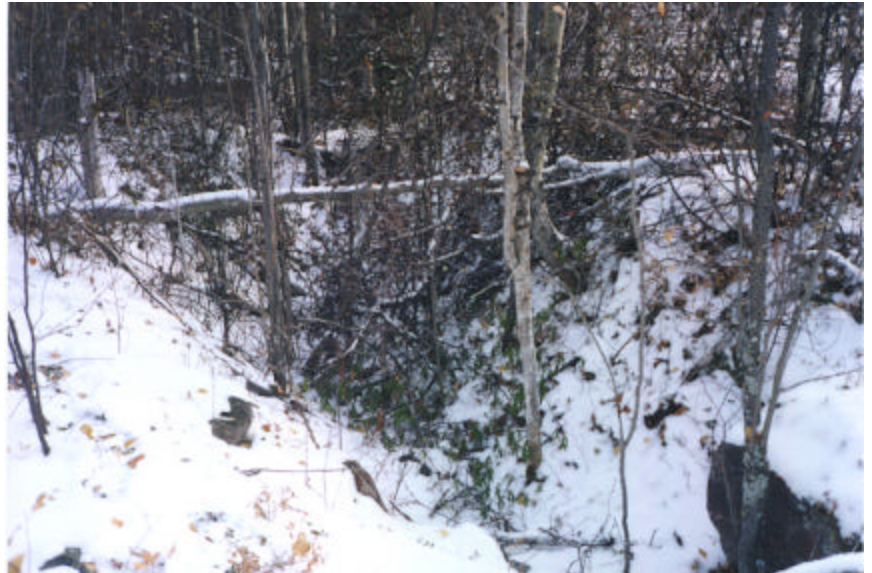
Photograph 6.13-1. SYE/Sunset Exploration Site-Trench 'D'-October 21, 2002.

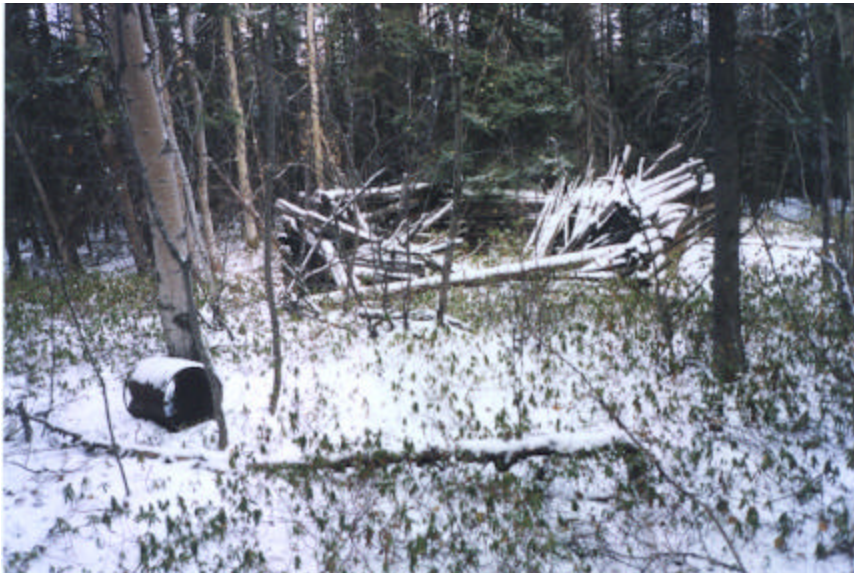
Photograph 6.13-2. SYE/Sunset Exploration Site-Trench-Delapidated Building-October 21, 2002.

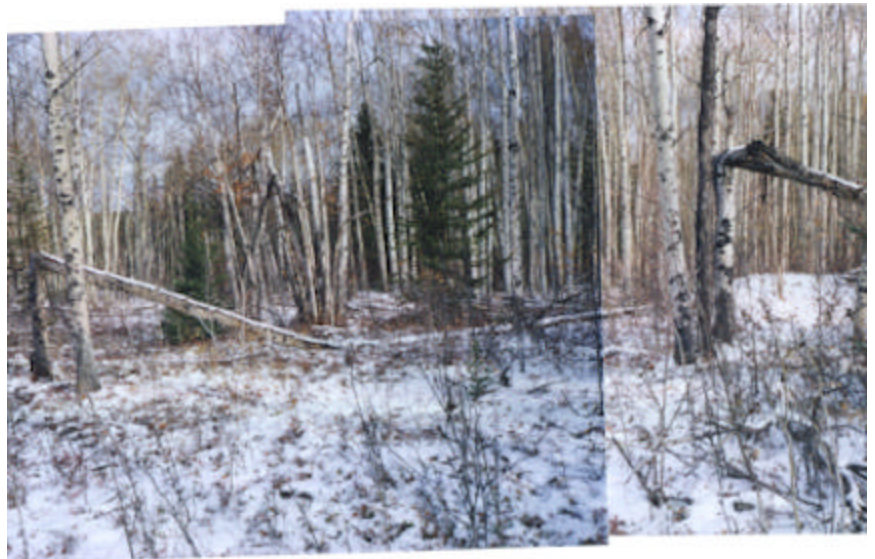
Photograph 6.13-1. SYE/Sunset Exploration Site-Panoramic View of 'A' and 'B' Trenches -October 21, 2002.

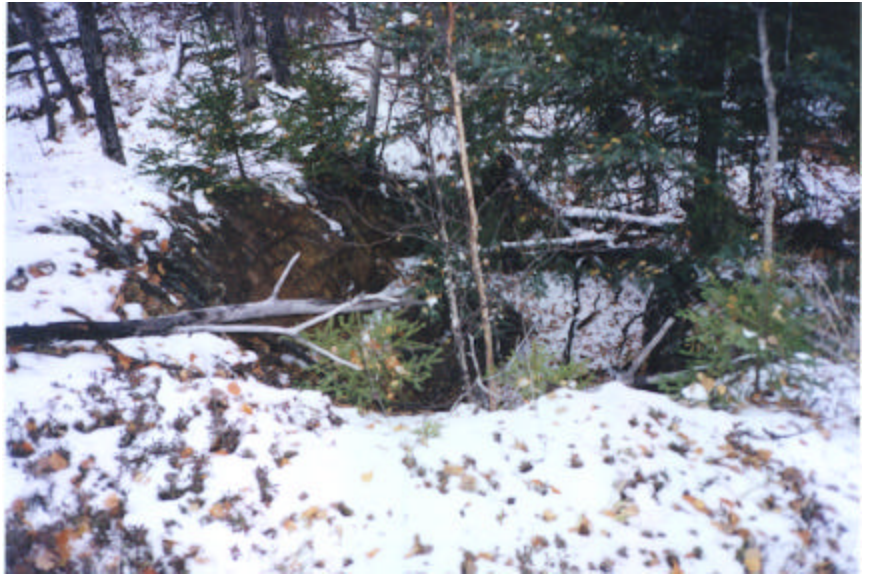
The East Adit is on the east side of the ridge, and 100 m southeast of the West Adit. A rock cut (1.8 m wide and 4 m long) into the bedrock forms the entrance to the adit opening. Waste rock and/or loose fallen rock has accumulated at the opening, effectively blocking any access into the adit. The rock slope at and above the entrance is stable but loose sheared rock was evident. Rock at the entrance is strongly sheared with intense sulphide and limonite staining. Standing water was evident in the adit, and was 0.7 m deep at the adit entrance. No external discharge from the adit was observed. The East Adit presents a sudden fall hazard, if approached blindly from the upslope side.

Photograph 6.15-1. Amisk Syndicate Mine-East Adit Area-October 21, 2002.

Follow-up work is required at the site to seal the openings to the two adits, either by blasting down the entrance way rocks or placement of a concrete seal over the openings. Blasting would also reduce the vertical wall heights, lessening risk of a fall hazard. Hazard warning placards should be posted should reclamation activity be delayed.

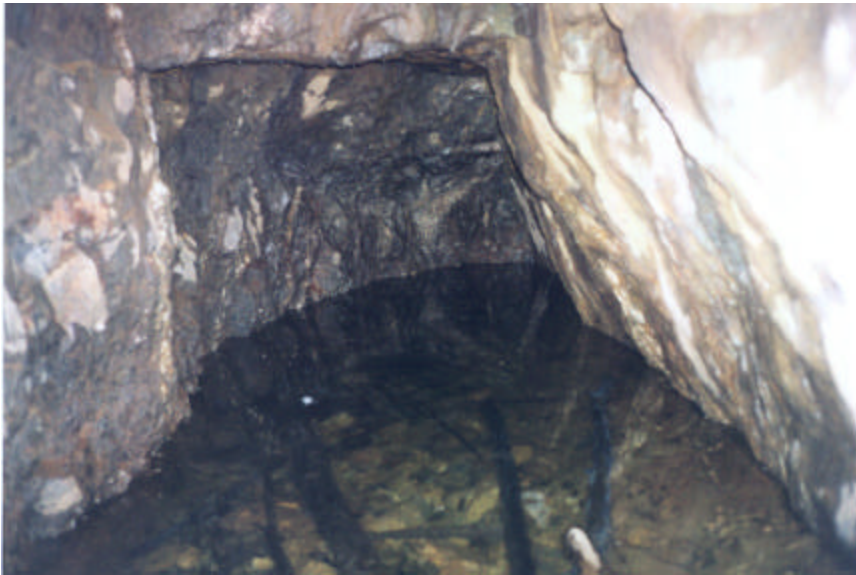
The West Adit occurs on the west side of the ridge, about 6m above the lake shoreline. A rock cut (1.2 m wide and 4m long) into the bedrock, forms the entrance to the adit opening. The adit opening itself is 1.2 m wide and 1.4 m high, slopes slightly downward to the east, and is easily entered. The adit is 30 m long, with the east half flooded with water to a depth of about 0.6 m. The water level in the adit is well above the adjacent lake. No external discharge from the adit was observed. Overall rock stability is good, but loose boulders and soil occur above the opening and fallen rock has accumulated at the adit entrance. Inside the adit, loose rock was visible on the back (ceiling) and has also fallen onto the floor. The West Adit presents a public safety hazard, if entered or approached blindly from the upslope side.

Photograph 6.15-2. Amisk Syndicate Mine-Partially Flooded Interior of West Adit-October 21, 2002.

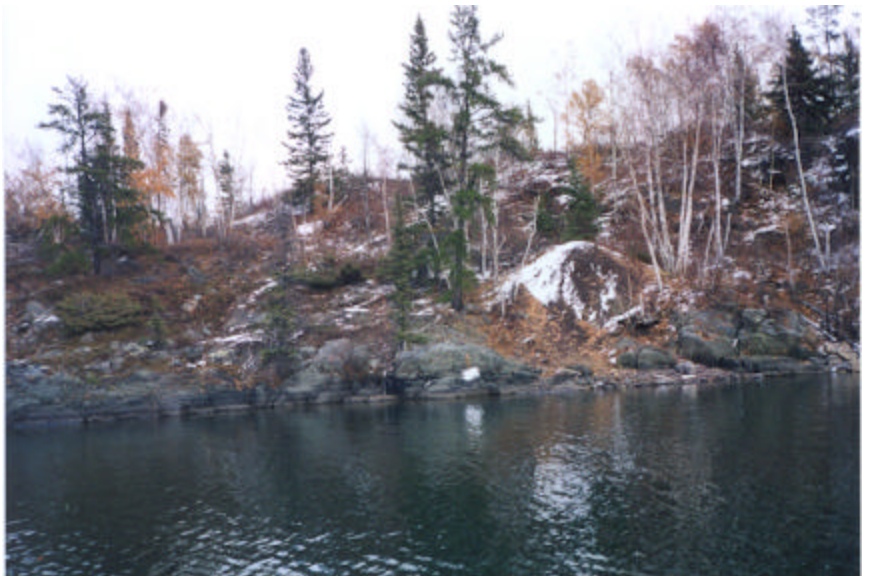
At the West Adit, the waste rock pile is about 6 m long by 2.5 m (crest) to 8 m (toe) wide and 1 m deep. The estimated volume of waste rock is about 48 m³. The slope (facing Comeback Bay) was 40 degrees. The pile extends from the rockcut entrance downslope to the edge of the lake. The pile consists of finely crushed (less than 0.5 cm) and pebble sized pieces of a carbonate altered chlorite schist showing brown staining. Birch trees encroached onto the sides of the waste rock pile, but there was no vegetation on the surface. Precipitation runoff across the pile would be direct into the lake, and thus present an environmental hazard.

Photograph 6.15-3. Amisk Syndicate Mine-West Adit and Waste Rock Pile-October 21, 2002.

The waste rock could likely be left as is, because adit water quality is neutral suggesting the host rock (waste rock) is non-acid producing.

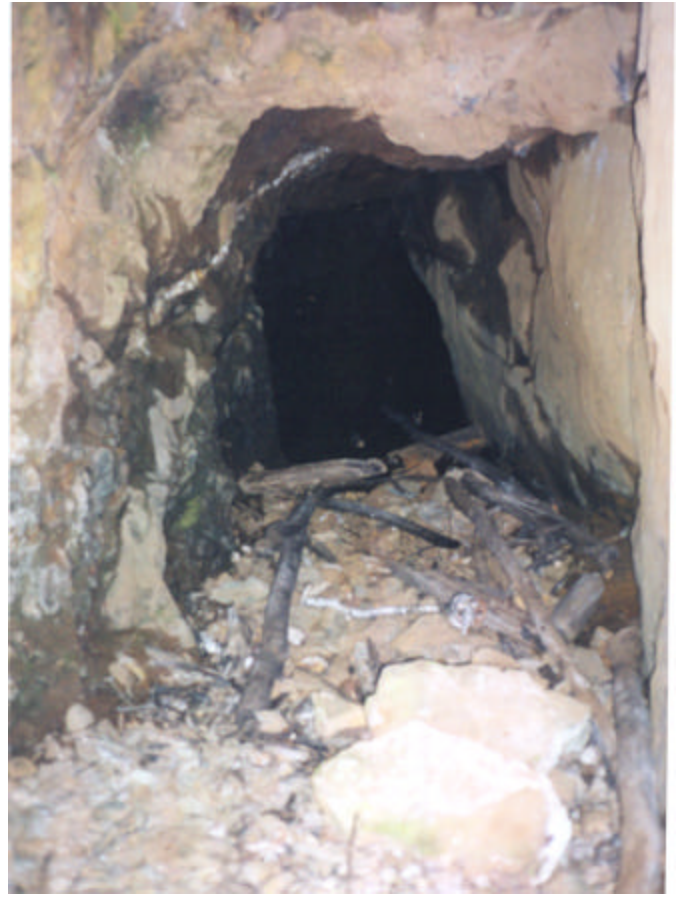
Photograph 6.15-5. Amisk Syndicate Mine-Interior of West Adit-October 21, 2002.

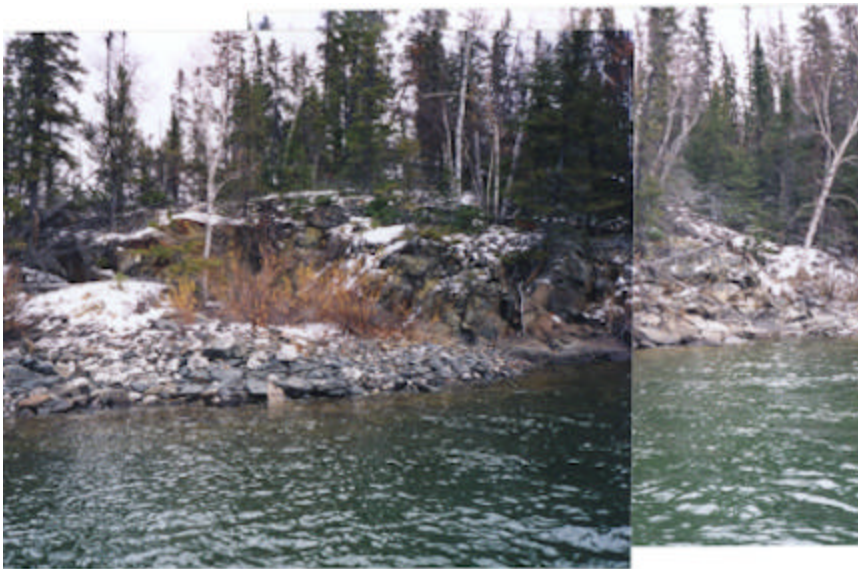
Photograph 6.16-2. Hannay Deposit View of Site Along Shoreline-October 22, 2002

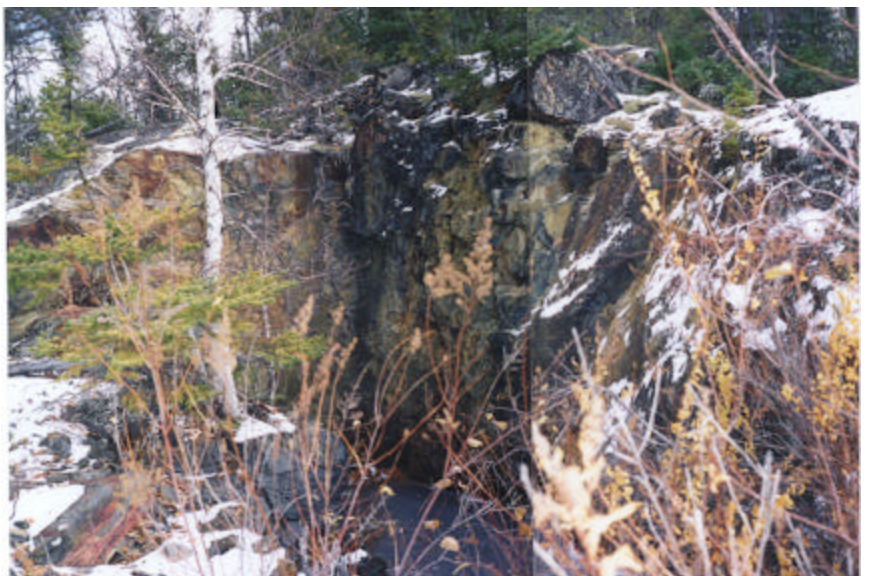
Photograph 6.16-3. Hannay Deposit Trench 'A'-October 22, 2002

Follow-up activity should be considered, involving the back-filling of the two trenches to reduce the potential fall hazard. The surrounding waste rock can be pushed back into the trench.

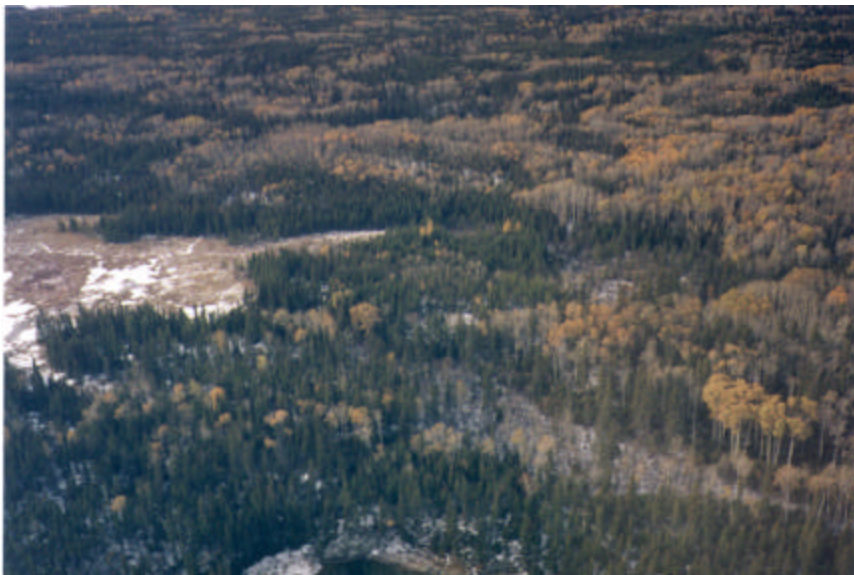
Photograph 6.17-2. Ace Deposit-Aerial View-October 23, 2002.
